### Shear behaviour of rock joints under cyclic loading

# Shear Behaviour of Rock Joints Under Cyclic Loading

## ABSTRACT

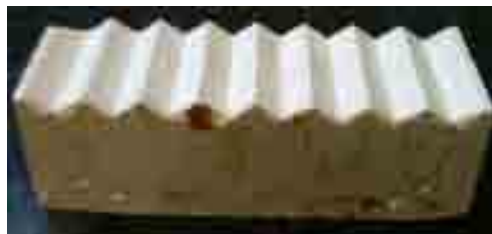
The joint surface was prepared based on a regular triangular saw tooth shape with inclination angle equal to  $26.5^\circ$  as shown in Figure 2. This artificial synthetic rock, allows for controlled repeatability of the initial roughness and the effect of asperity degradation under cyclic loading can be analyzed conveniently. The joint surface area for all the samples is  $187.45 \text{ cm}^2$  ( $250 \times 75 \text{ mm}$ ) with a total of 8 asperities  $30 \text{ mm}$  long in the direction of shearing with an amplitude of  $7.48 \text{ mm}$ .

Figure 2. A close view of artificial joint prepared for testing

In this study, Gypsum plaster ( $\text{CaSO}_4 \cdot \frac{1}{2} \text{H}_2\text{O}$  hemihydrates, fraction of  $\text{CaSO}_4$  to  $\text{H}_2\text{O} = 3.5:1$ ) was used to mould the artificial rock joints. This material can take any desired shape when mixed with water and the long term strength is independent of time once the chemical hydration is complete. The initial setting time of plaster is about 25 minutes. Furthermore, the cured plaster mix shows a repeatable uniaxial compressive strength in the range of 11 to 13 MPa and a Young modulus of 1.9 to 2.3 GPa which are parameters comparable to many sedimentary rocks. Testing on planar joints with the Gypsum Plaster showed a basic friction angle of approximately  $35^\circ$ .
